Intel[®] Pentium[®] III Xeon[™] Processor Specification Update

Release Date: September 2000

Order Number: 244460-020

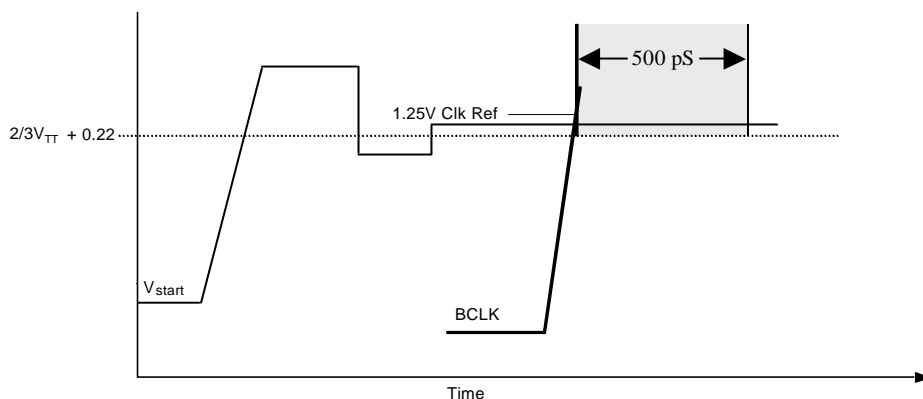
The published AGTL+ AC specification for $V_{IH(MIN)}$ is $(2/3 \cdot V_{TT}) + 0.1$ Volts.

Intel has characterized the new AGTL+ AC specification for $V_{IH(MIN)}$ on the processor's RS0# signal to be: $(2/3 \cdot V_{TT}) + 0.22$ Volts within 500 picoseconds following the rising edge of BCLK crossing the 1.25-Volt threshold. See below.

Implication: The deviation from the published specification results in decreased noise margin on the RS0# processor input. This decreased noise margin has been observed to be particularly detrimental in system environments where the RS0# processor input is being driven by an I/O buffer with a pull-up device (such as a p-channel transistor) that is switched off mid-cycle. Systems that employ I/O buffers that keep the pull-up device on for the entire cycle are significantly less affected by this erratum. The reduction in noise margin may lead to the generation of BINIT# (when enabled) resulting in a system reset, otherwise this condition may lead to a system "hang" condition.

Workaround: If a system design cannot meet the specification deviation, the following areas should be carefully examined to assure that additional margin exists in order to compensate for any deficit observed with respect to the newly characterized $V_{IH(MIN)}$ specification:

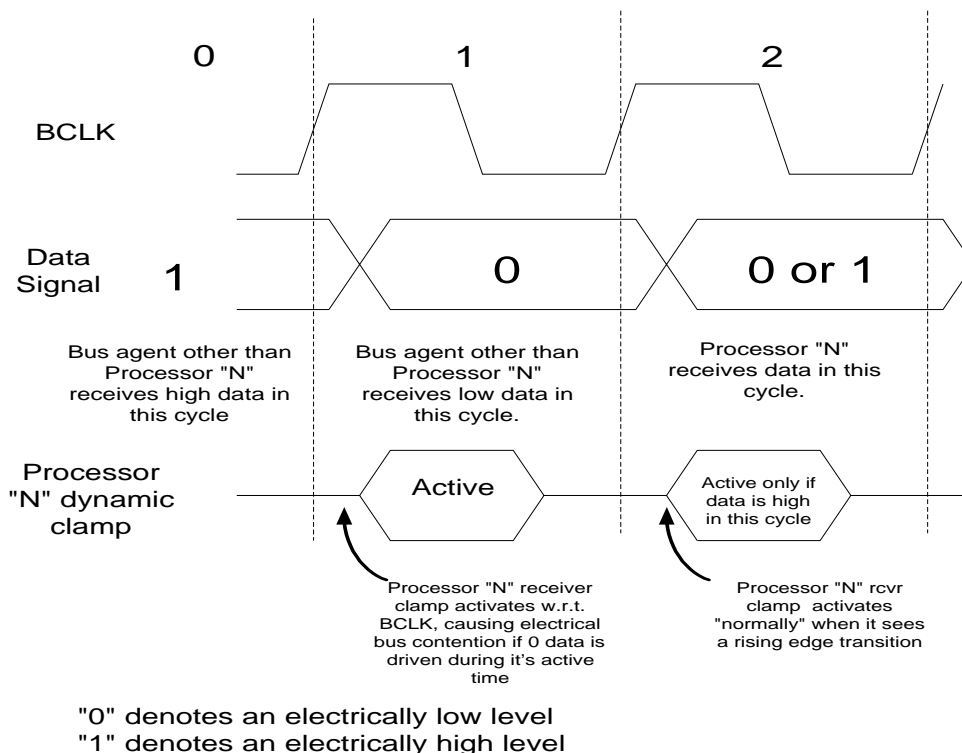
Problem: Falling edge ledge push-out and undershoot may be seen on AGTL+ data and data bus ECC signals. The AGTL+ receiver's dynamic clamp circuit activates (i.e. clamps the signal to an electrically high level) in certain cycles when data is driven to an electrically low level by another agent.

Implication: This erratum only occurs on a processor that does not receive data in that particular cycle. More specifically, this erratum only occurs when a specific processor does not receive data in the current BCLK period, but receives data in the very next period. Therefore, the processor inducing this falling edge noise (on data and data bus ECC signals) will not actually read the data in that cycle. See below for an illustration of this erratum affecting a processor denoted Processor "N". The falling edge ledges and undershoots may affect the signal quality and/or timing at agents that receive data in that cycle. Therefore, the impact of this erratum is highly dependent on system bus design.

Workaround: Evaluate system bus signal quality and timing margin at the valid receiving agent as a result of this falling edge noise. Due to dependence upon system bus design, bus layout may be evaluated to determine the need for improvements in signal quality and timing margin at the valid receiving agent as a result of this receiver-induced falling edge noise.
